Libor BENEŠ\*

INFLUENCE OF THE SURFACE CONTACT PHENOMENA ON THE STRUCTURAL  
CHANGES AND NANO-LAYERS GENERATION

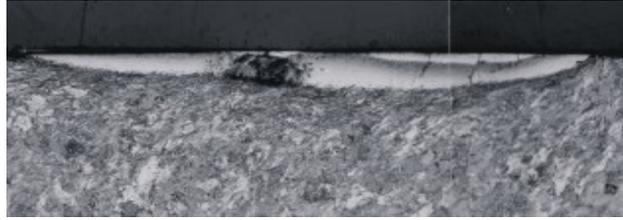
Therefore, explanation of the acting mechanisms and effective factors represents a crucial task towards reduction of occurrence of the contact-fatigue defects in rails mentioned above. When viewed in a microscope, the cross-section of an operated rail (**Fig. 1**) shows *riffle bands*, (surface corrugation of the rail head) in a layer approximately 10-100 µm thick, without a structural contrast, which is resistant to etching of metallographic samples and shows a white colour after etching with Nital. This layer is often considered or identified as martensite. As this area exhibits exceptional fragility, propagation of defects known as *squat* or *shelling* and occurrence of defects is observed in the rail head. All of the above result in background noise when the wheel travels along the rail and exhibit a detrimental effect on the service life of the rail and of the wheel axle (Lojkowski W. 2001).

**Fig. .1** White Etching Layer (WEL) on the surface of the rail (Wang L. 2002). NITAL, magn.100x.

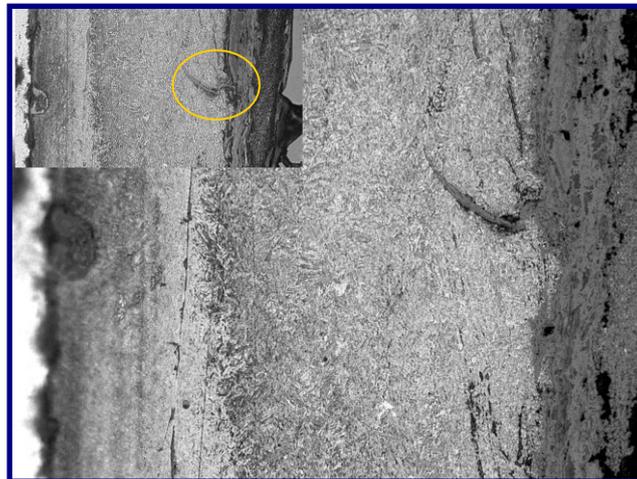
The analyses performed show that the WEL itself consists of several sub-layers; this suggests gradual generation of the layer during operational exposure (see **Fig. 2**). The figure also shows a tendency to layer delamination along the boundary with unaffected mass in the sub-surface area of the rail head, which is the result of a high hardness gradient and, therefore, of local stress conditions acting on both sides of the boundary area. The cumulative effect of the tangential shearing components in the area of contact causes separation of material masses from the rail head and is the cause of occurrence of the studied defects on the surface.

**Fig. 2.** Microstructure of the rail-segment after annealing on 250°C / 4hrs. Etched in NITAL, magn. 250x and 50x, resp.

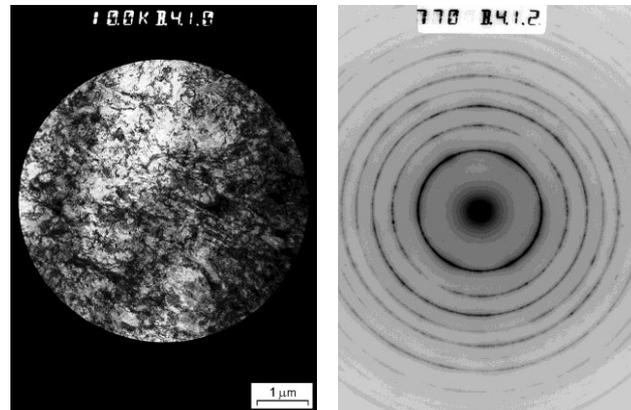
approximately from 20 to 200 nm. Therefore, the microstructure may be identified as nanocrystalline (see **Figure 3**), highly homogeneous; the grains are of irregular shape and are separated by clusters of dislocations. Annular diffractions (**Figure 3**) show that only ferrite is present in the material; presence of carbides may be expected; however, the diffraction sensitivity in the situation is not sufficient as to show carbides in the image. Presence of austenite has not been demonstrated. The deformation level of the structure is so strong that the carbide contrast in normal images is obstructed by the contrast from a dislocation clusters.

**Fig. 3.** TEM-image of the region where the selected electron diffraction was carried out; the obtained annular diffraction pattern proved that the microstructure consists of very small ferrite grains with random orientation.
