Michal BARCIKOWSKI\*, Waclaw KRÓLIKOWSKI\*\*

CHARACTERISTICS OF IMPACT DAMAGE AND POST-IMPACT STRENGTH IN GLASS-FIBRE-REINFORCED PLASTICS WITH DIFFERENT REINFORCEMENT ARCHITECTURE

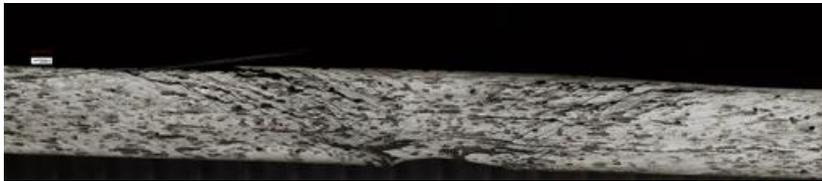
**Fig. 7** Microsections through the center of the damaged area in: a) CFM, b) 6RT, c) 10RT, d) RF, and e) TYF after 16 J impact.

Fig. 7 presents microsections through the center of the damaged area in the composite materials used in the study. There is a striking difference between CFM-reinforced composite and all of the composites reinforced with woven fabrics. In the latter, the damage consists of delaminations occurring every few plies. In the former, the damage forms conical shape. The centre of this cone is relatively undamaged and seem to be subjected, during the impact event, to translation without deformation. This difference in the character and shape of damage readily explains the lack of leakage through woven-fabric-reinforced composites – through-the-thickness fissures that could allow the water through were present only in mat-reinforced composites.

The question that arises is: why so dramatic difference? Our proposition of the answer stems from the technology of composite manufacture. The continuous-filament mat consists of fibers which are bound with a binding agent, which is soluble in a polyester resin. After the mat is infused, the binding agent dissolves and each lamina disperses, leading to *quasi-isotropic* fiber distribution. In woven fabrics, however, the fiber strands are mechanically bound (woven), so the laminae remain compact and well defined. Between the plies of reinforcement, there exists a layer of neat, non-reinforced resin which constitute ready path for crack transmission.
